**Title of Thesis:** *Modes of Rock Slope Movement in the Colin Range, Jasper National Park*

*Modes of Rock Slope Movement in the Colin Range, Jasper National Park*

Department of *Earth and Atmospheric Sciences*

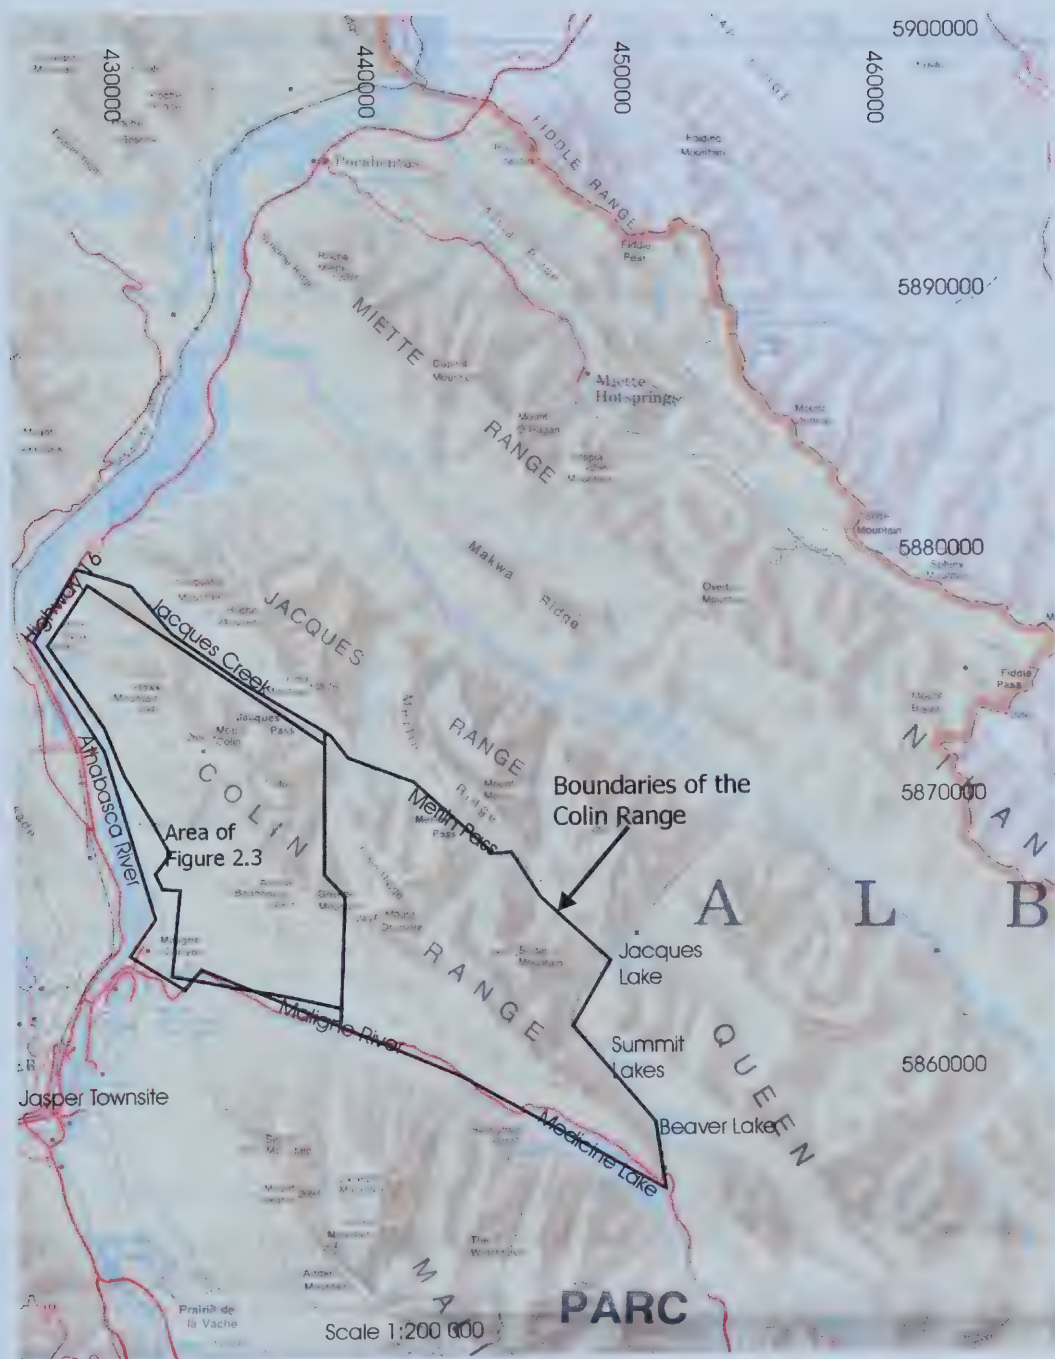
Figure 2.1 – Topographic map showing the Colin Range and the area of the geological map in Figure 2.3. The figure is derived from the 1:200 000 topographic map of Jasper National Park by the Surveys and Mapping Branch, Energy, Mines and Resources Canada (1985).

The study area is located in the Colin Range of Jasper National Park, in the Front Ranges of the Rocky Mountains, within the Canadian Cordillera. The southwest facing slopes of the Colin Range, where the Athabasca River cuts the Colin Range, are the focus for this study (Figure 2.1). The region is bounded to the northwest and the west by the Athabasca River, to the south by the Maligne River and to the east by the summits of Morro Peak, Hawk Mountain, Mount Colin and Roche Bonhomme. All of the individual sites were accessed by the Overlander Trail in Jasper National Park.

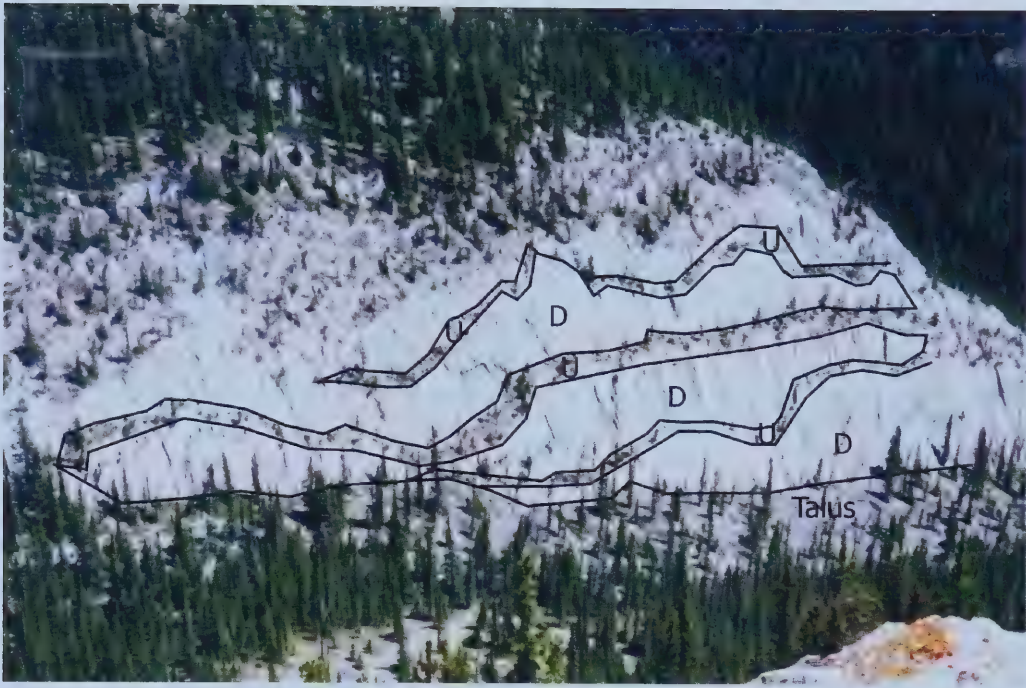
Figure 2.8 – Photograph of a ridge to the east of Morro Peak, taken from Morro Peak, showing a cataclinal underdip slope composed of alternating dip slopes, D, and underdip slopes, U. This is a relatively steep cataclinal underdip slope that is formed in steeply dipping beds. The location of this slope is indicated on Figure 2.7.

Large dip slopes are not common, as the process of buckling often reduces slopes (Cruden and Hu, 1996). On a much smaller scale, dip slopes were observed to exist within cataclinal underdip slopes (Figure 2.8). The distribution of dip slopes is shown in Figure 2.9. One mode of movement on cataclinal dip slopes will be further discussed in Chapter 4.3.

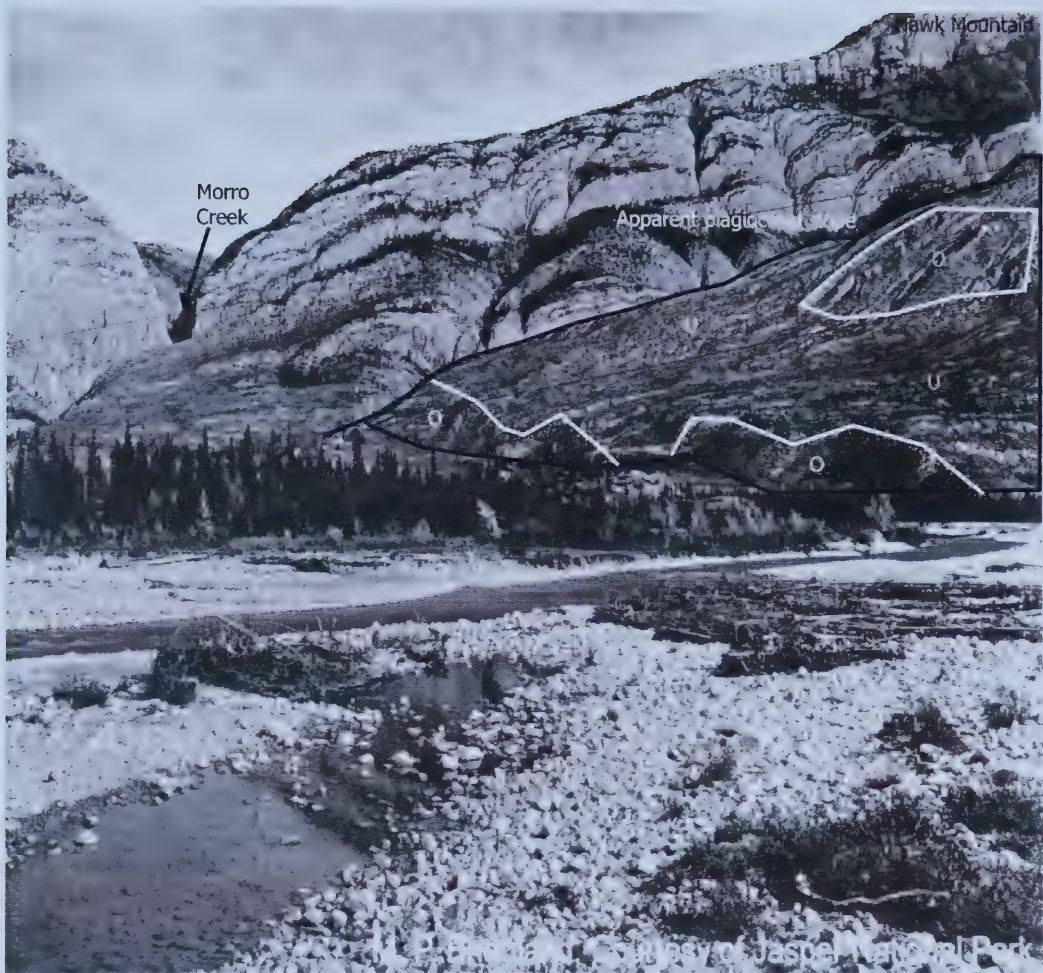
Figure 2.12 – Oblique photograph of an apparent plagioclinal slope, which is composed of orthoclinal slopes, O and cataclinal underdip slopes, U. Photograph number 485 from the Bridgland Repeat Photography, taken by M.P. Bridgland in 1915 (Higgs, 2001). The bedding is striking from the left to the right in the photograph, and dipping out of the page. The photograph was taken to the northeast.

Aerial photographs and terrestrial photographs (Figure 2.12) are valuable tools for the mapping of slope types and the further analysis of hazards. Aerial photographs, with the use of other geological information, can be used to successfully divide slopes into anaclinal, cataclinal, orthoclinal and plagioclinal slope types. This is useful for landslide hazard analysis, as it focuses the study, as some slope movements occur on specific slope types. For instance, large rapid rock slides typically occur on overdip cataclinal slopes (Cruden, 1976; Cruden, 1982).

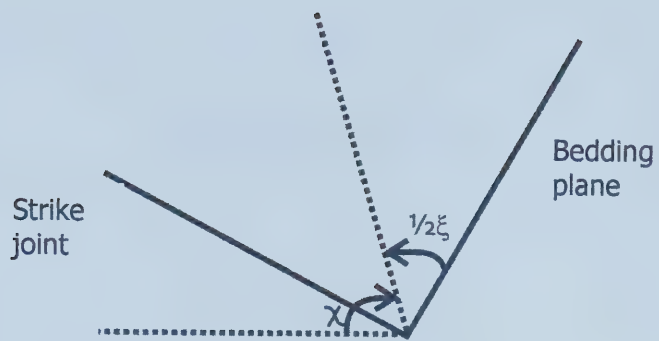
Figure 3.7 – Geometry of an orthoclinal wedge after Hoek and Bray (1973).

Parameters W, U and V are defined for a 3-dimensional wedge as shown in Figure 3.3, and as follows

$$W = bhs\gamma_r(\sin \psi_b + \cos \psi_b)$$

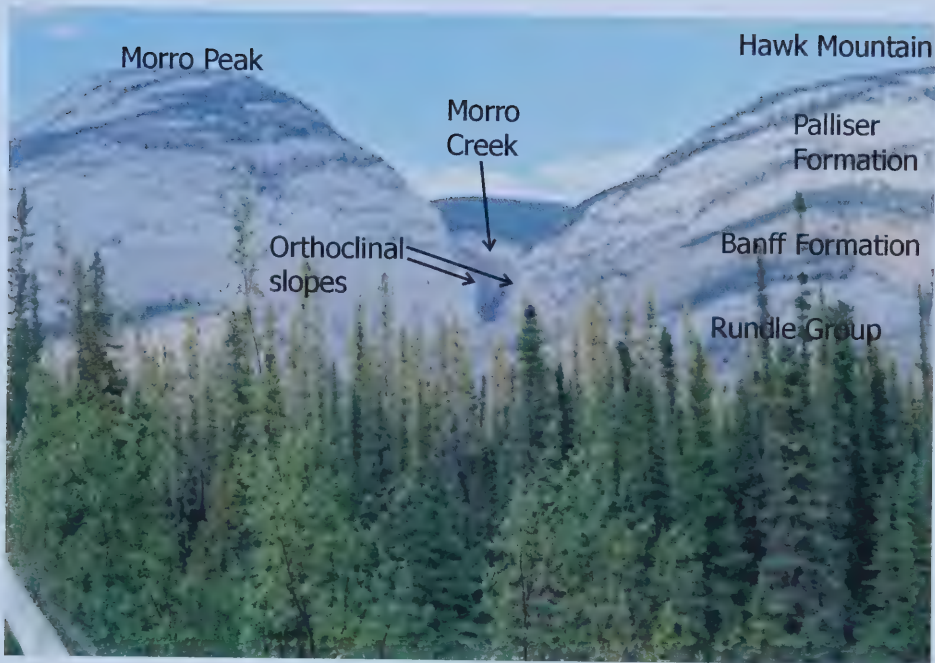
Figure 3.14 – View of the canyon of Morro Creek taken from the Snaring River Bridge on the secondary road. The bedding is dipping to the southwest at  $70^\circ$ , and the canyon is cut at a right angle to the bedding.

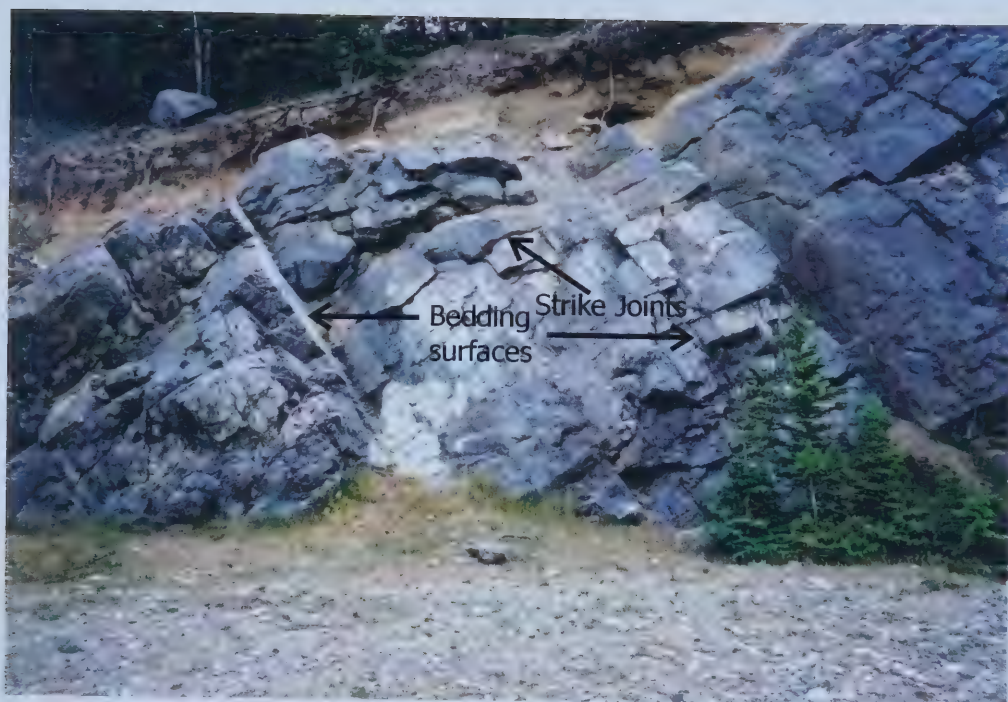
Figure 3.16 – Photograph of the cut slope adjacent to the Athabasca River (Figure 3.13). Photo is taken on a bearing of 130°.

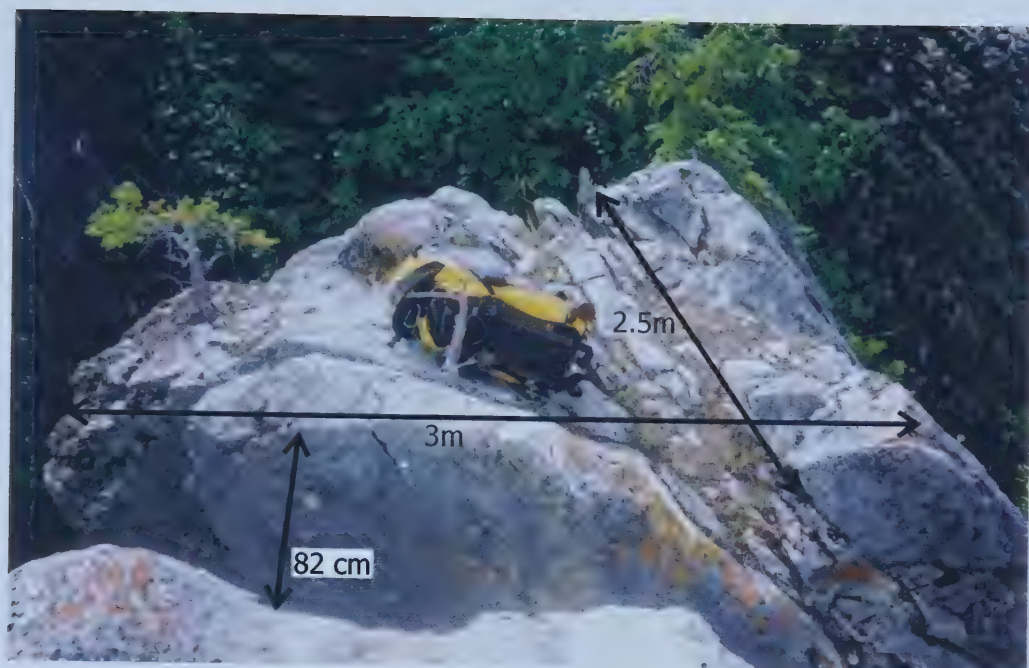
Figure 3.18 – Photograph of the top of the block that is in the process of toppling into Morro Creek.

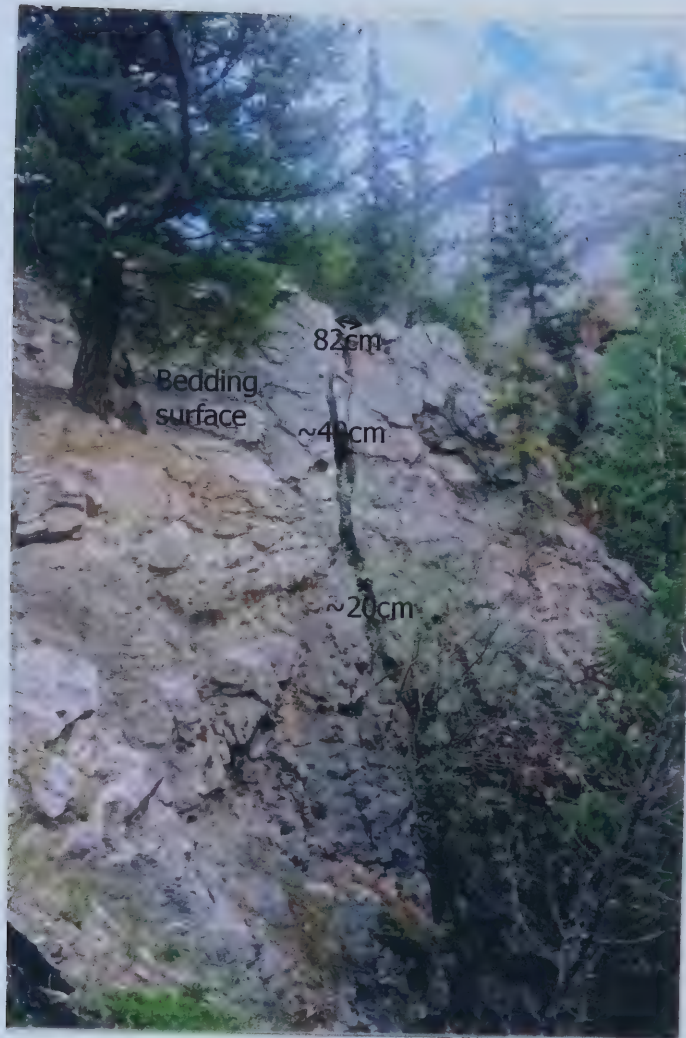
Figure 3.19 – Toppling block showing rotational type movement of the block to the right of the photograph, into Morro Creek. The photograph is taken looking at the bedding surface from the direction of dip.

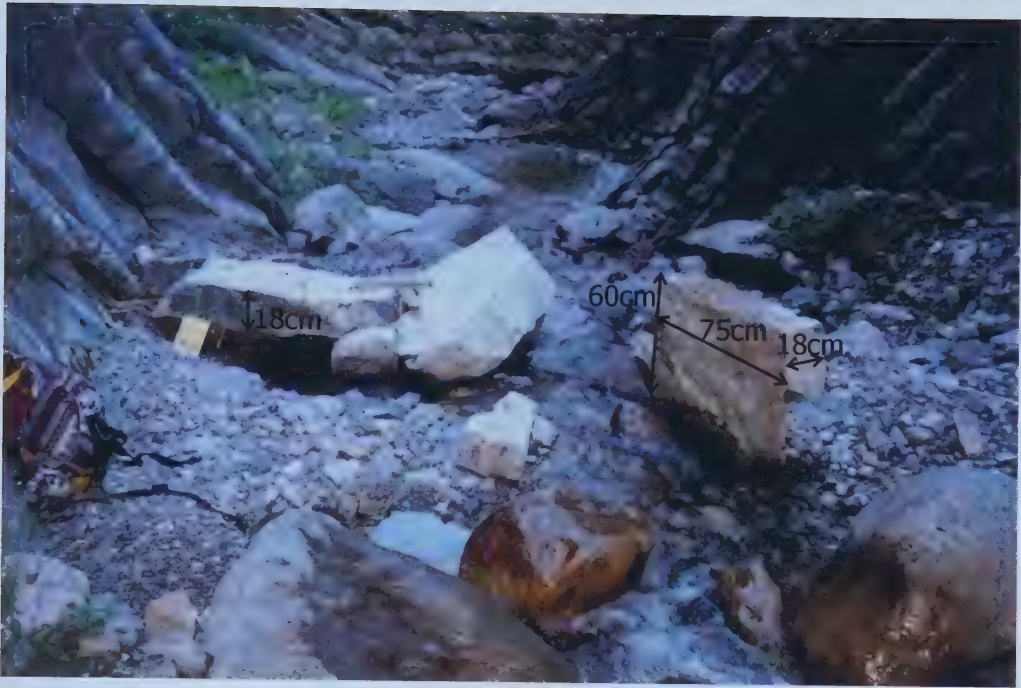
Figure 3.20 – Several blocks in Garrone Creek that look to have fallen recently. The blocks are angular, not rounded, and the block on the right is balanced on a thinner side. The long dimension of the block is parallel to the bedding, and the bedding spacing is 18cm.

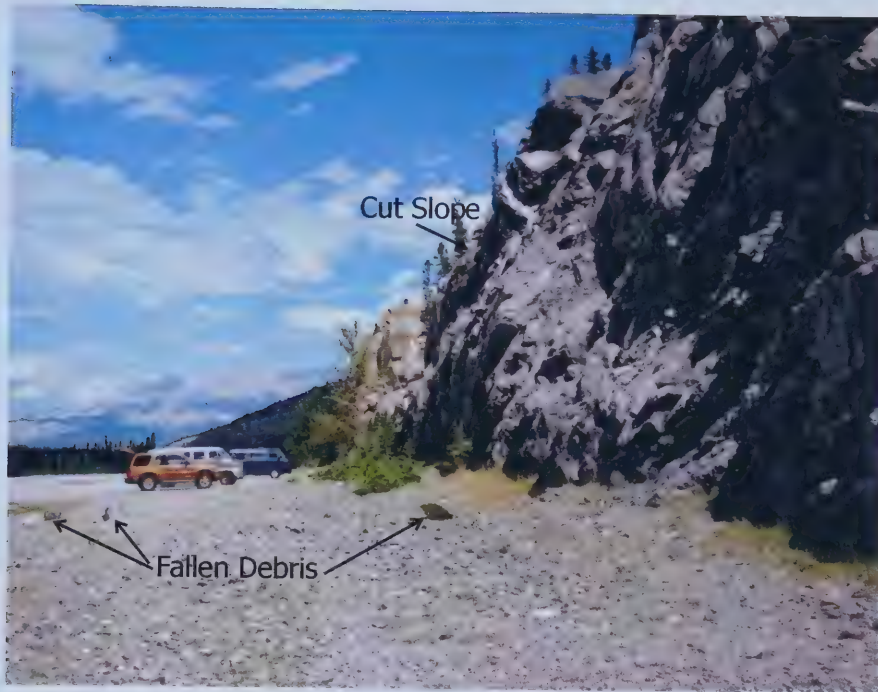
Figure 3.22 – View along the cut slope, looking northeast, showing the slope and several blocks at the base of the slope that have come off of the slope.

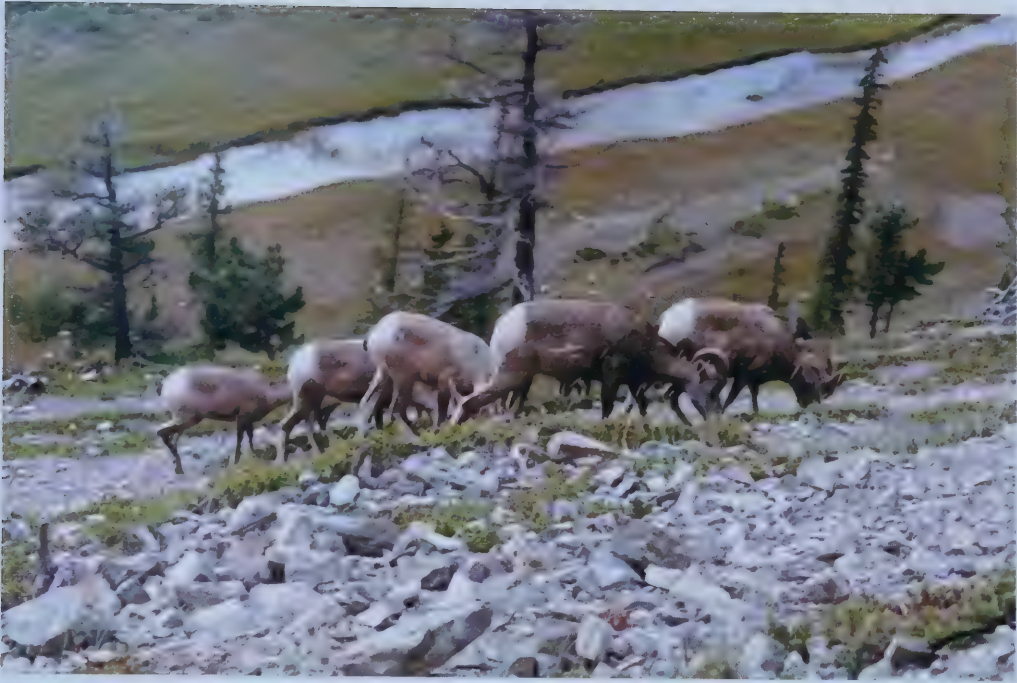
Figure 4.4 – Downslope at Location 2, showing the blocky talus deposits, the sparse vegetation and the use of the slope by Big Horn Sheep. The slope ends on the Athabasca Flood Plain, and blocks of rock can be seen resting on the flood plain.

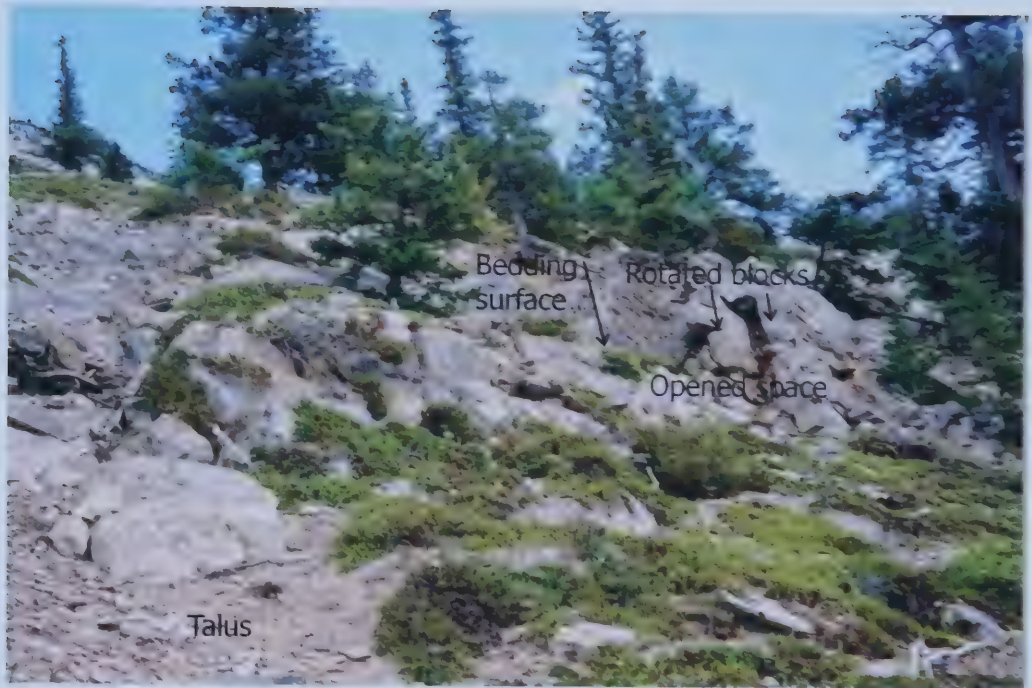
Figure 4.5 – Outcrop of Pekisko Formation along the Overlander Trail at Site 2. The in place bedding is shown, as well as the bedding that is showing some rotation.

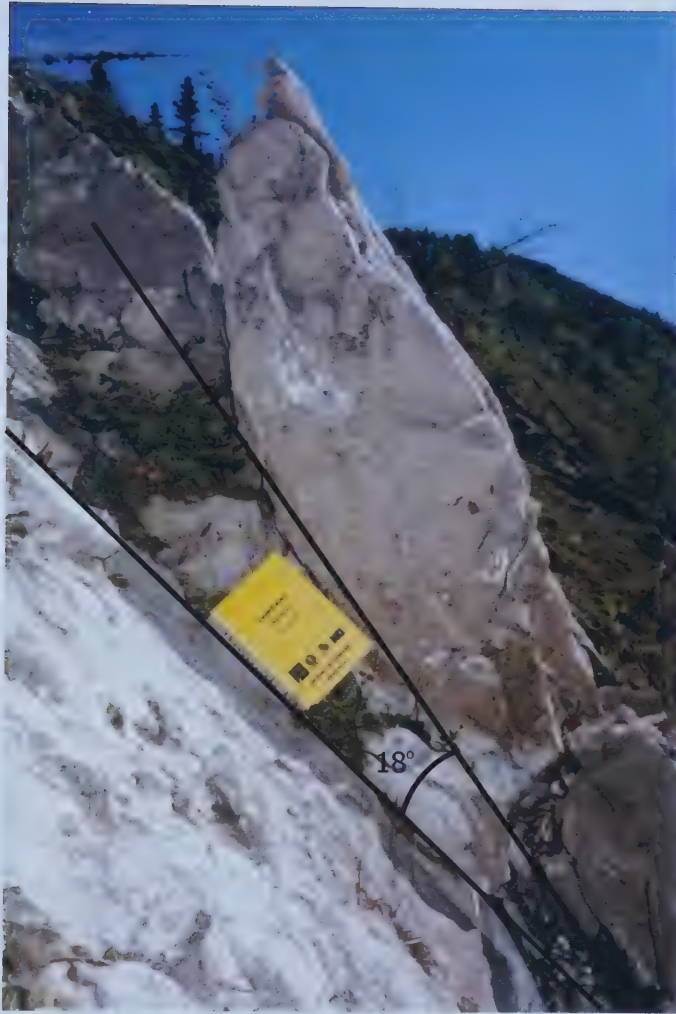
Figure 4.8 – Rotated block within the Turner Valley Formation at Location 4. The space that has been opened up by rotation has been subsequently infilled with debris, soils and vegetation.

Within the Turner Valley Formation, at UTM 11U 0428650 5874650, a block has been rotated  $18^{\circ}$  toward vertical from the bedding orientation of the slope (Figure 4.8). The space behind the block has been infilled with rock debris, soil and vegetation. This block is toppling from an underdip cataclinal slope, and the orientation of this block is plotted on Figure 4.1 as L4, and plots within the region for toppling on bedding..

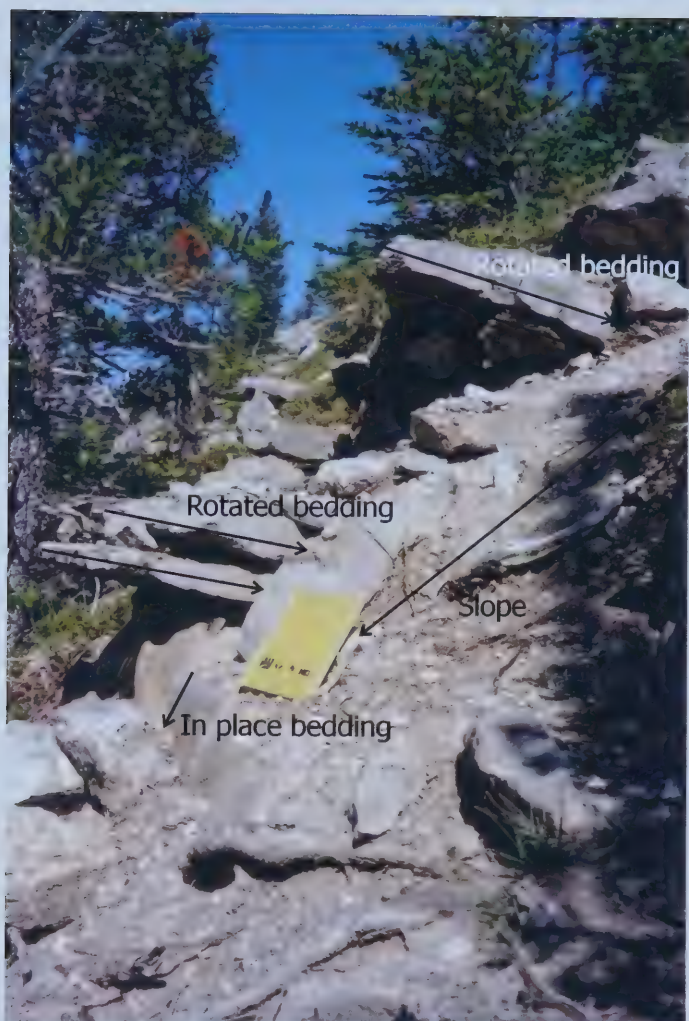
Figure 4.10 – Rotated bedding at Location 5 within the crinoidal limestone of the Banff Formation.

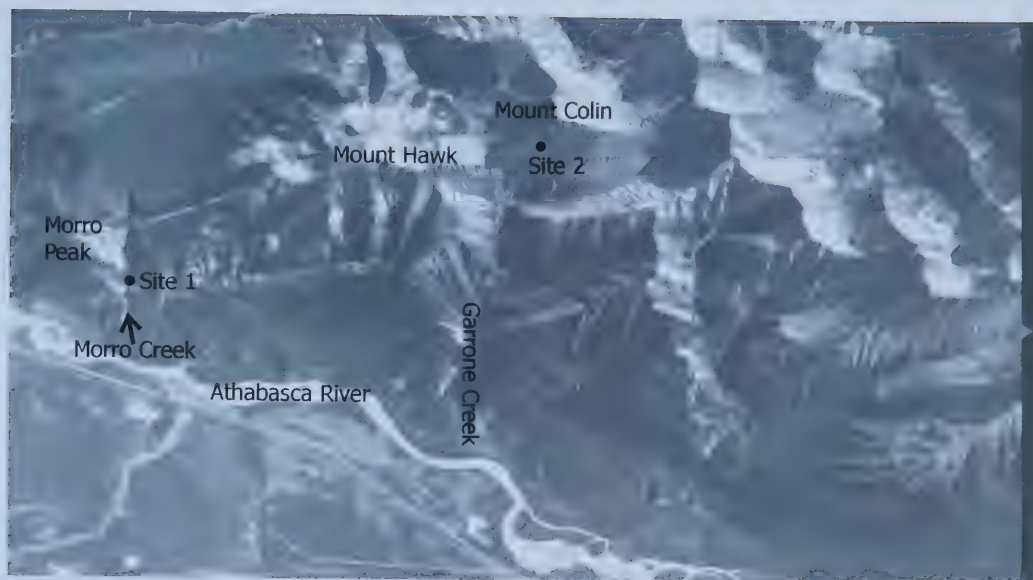
Figure 4.11 – Aerial photograph showing the location of Sites 1 and 2. Aerial photograph #A23015-138, originally at a scale of 1:60 000.

In areas of steep, cataclinal, underdip slopes, a different type of slope movement occurs, characterized by a circular to inverted teardrop shaped alcove on the slope surface. The two locations of this phenomenon are shown in Figure 4.11, and both occur within the Devonian Palliser Formation on the west slopes of the Colin Range.

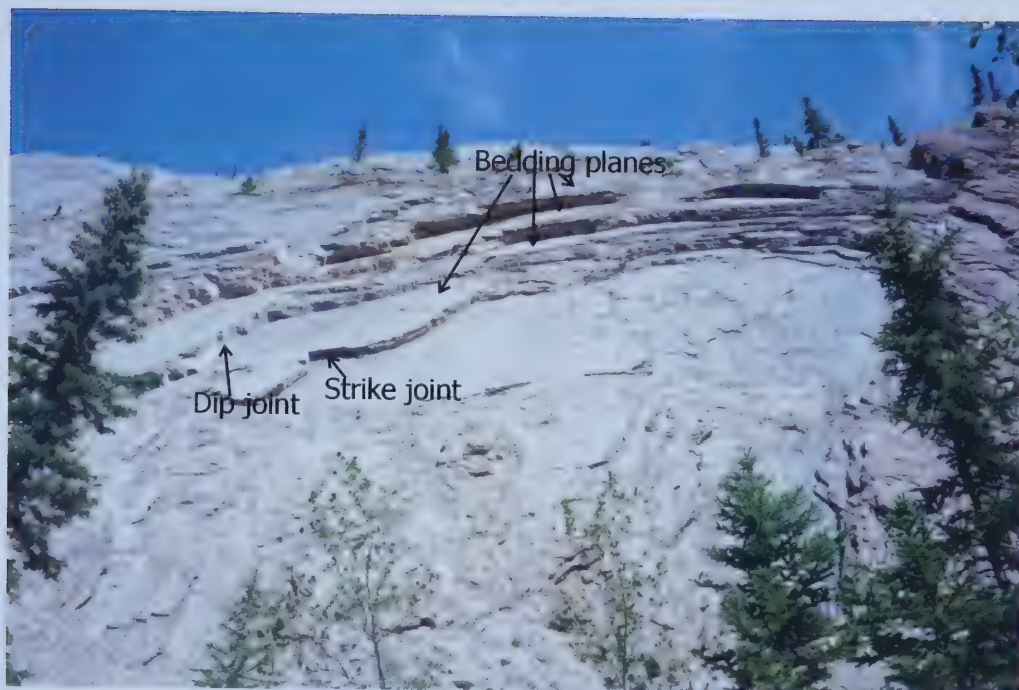
Figure 4.13 – Lower exfoliation at Site 1, taken from the bottom of the feature looking up along the dip of the bedding, showing the bedding planes that daylight in the feature, and the strike and dip joints.

Site 1 is on Morro Peak, at UTM 11U 0428500 5875800, where Morro Creek flows out of the steep-walled canyon through the Palliser Formation and into the less-resistant rocks of the Banff Formation, along the toe of the cataclinal underdip slope. The bedding at this location dips at 70° in the direction 221°, with a bedding thickness of 10cm to 35cm. Joint 1 spacing ranges from 20cm to 60cm, and the joint 2 spacing ranges from 20cm to 180cm. At this location two tear-drop shaped to circular concavities are found in the slope (Figure 4.12 and 4.13). These concavities occur one above the other, with the depression in Figure 4.12 occurring higher up on the slope than that of Figure 4.13.

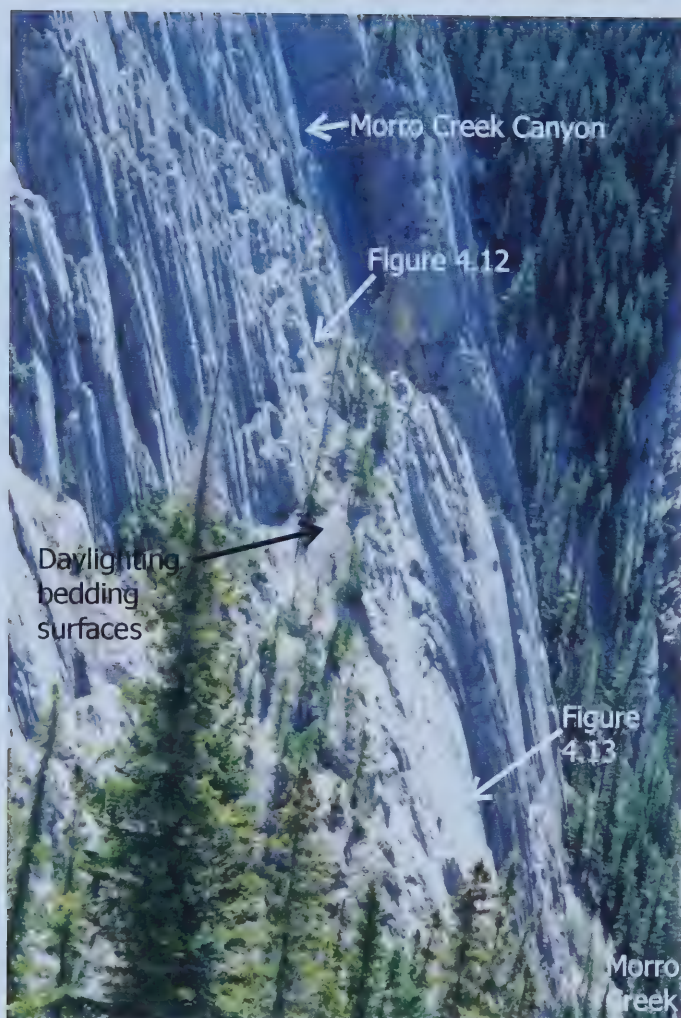
Figure 4.14 – View along the strike of bedding of the area of exfoliation at Site 1. The location of Figures 4.12 and 4.13 are shown, along with the daylighting bedding planes above the concavities and the location of Morro Creek and Morro Creek Canyon.

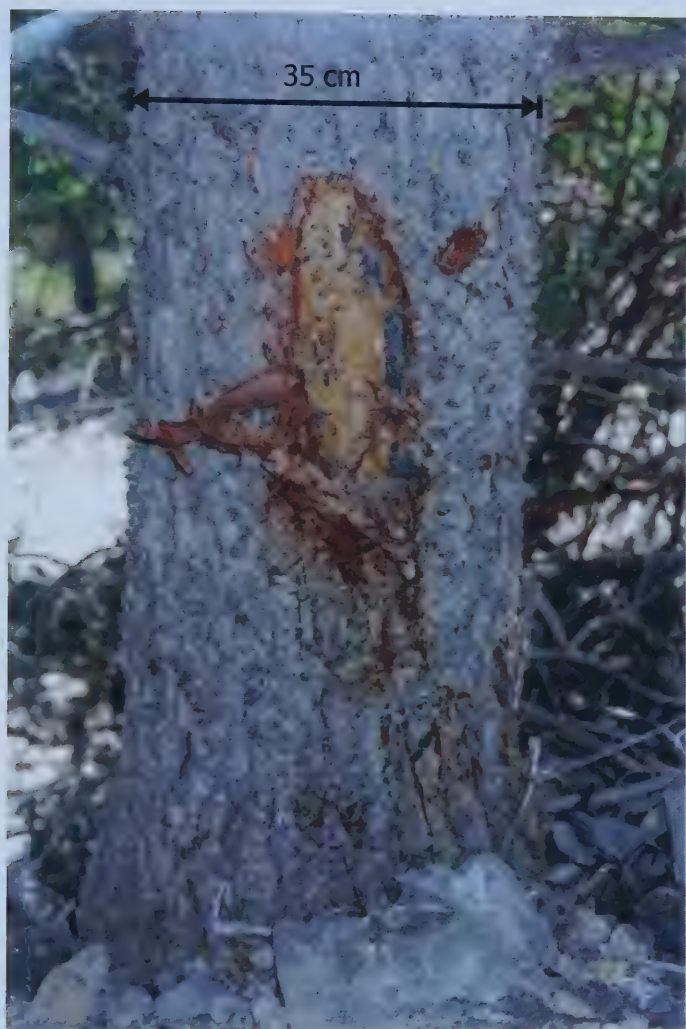
4.15 – Recent tree damage at the base of the slope of Site 1, below the areas of exfoliation. Talus blocks can be seen where there is a build up of talus up slope of the tree trunk.

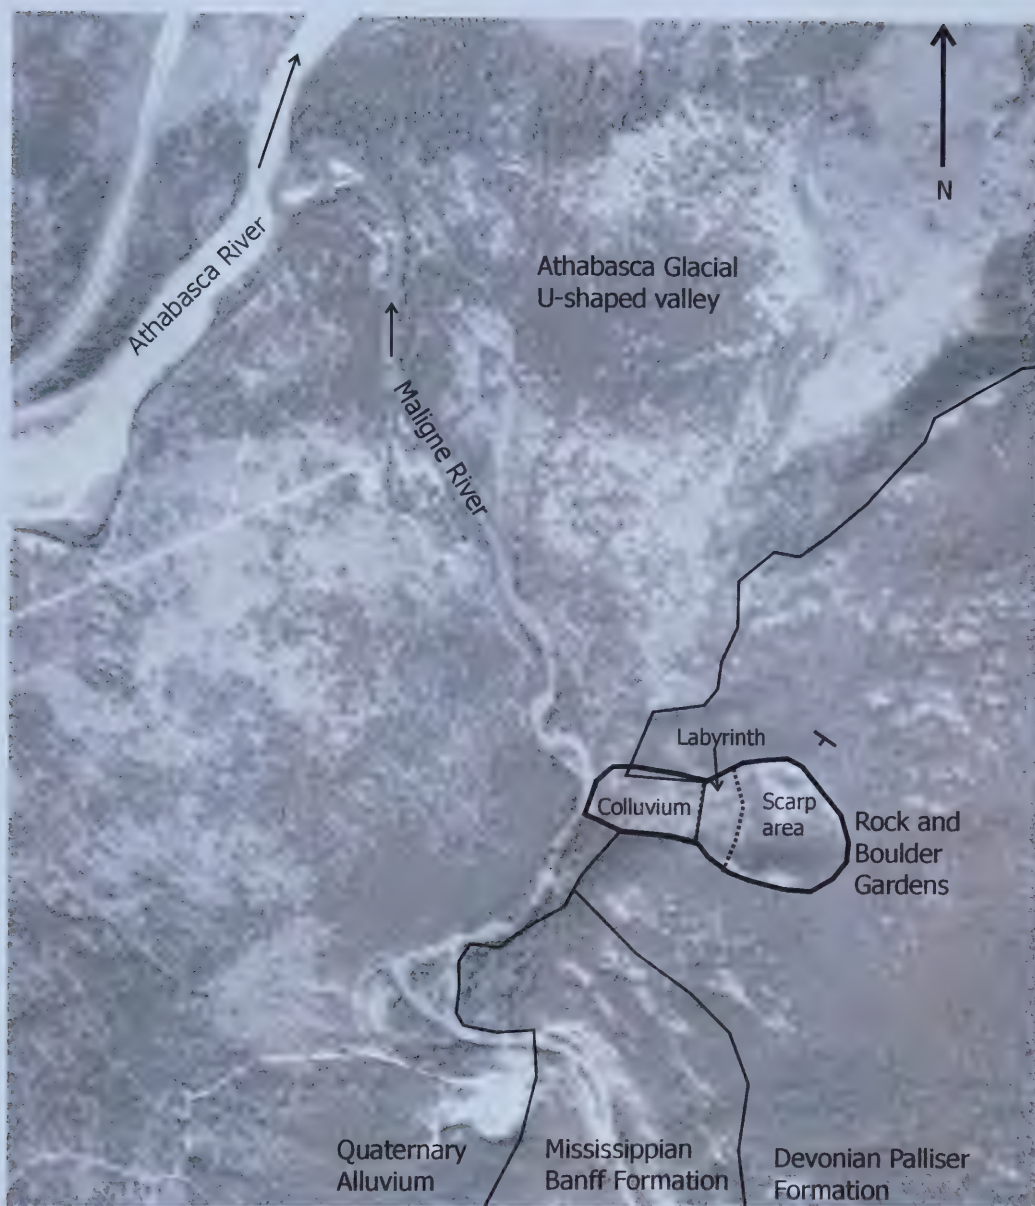
Figure 4.20 – Aerial photograph at a scale of 1:20 000, showing the bedrock geology in the vicinity, the scarp area, the labyrinth area and the colluvial area of the Rock and Boulder Gardens. Photograph courtesy of the Jasper National Park Wardens Office.

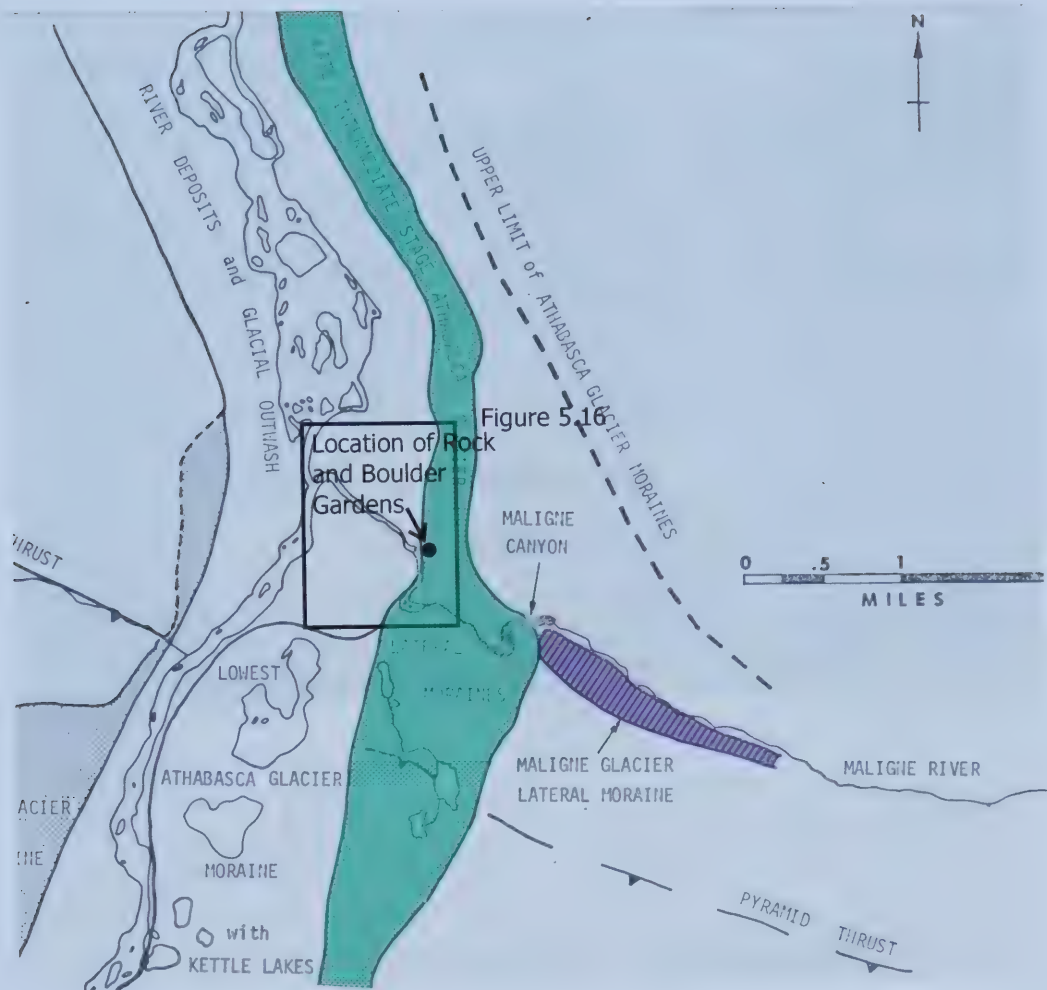
Figure 4.22 – Detailed map of the surficial geology in the vicinity of the Rock and Boulder Gardens (Mountjoy, 1974), showing the location of the Athabasca Glacier Moraine in green and the Maligne Glacier Lateral Moraine in purple.

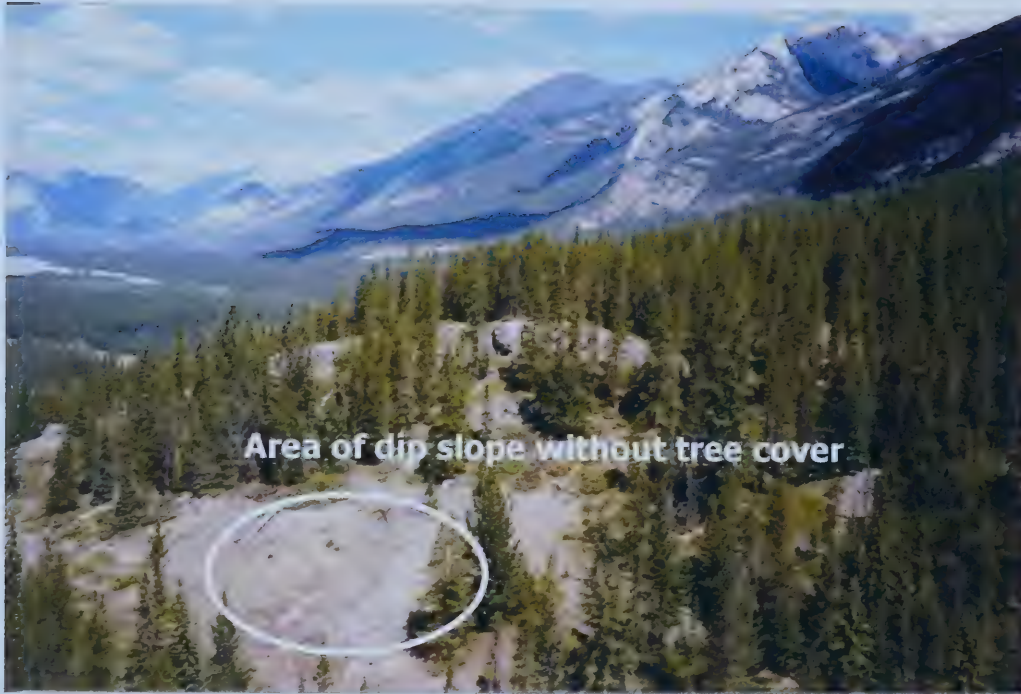
Figure 4.23 – View from the south scarp toward the north scarp, showing the tree cover in the bowl area. The area with no tree cover is a dip slope. The north scarp of the feature can be seen in the middle ground.

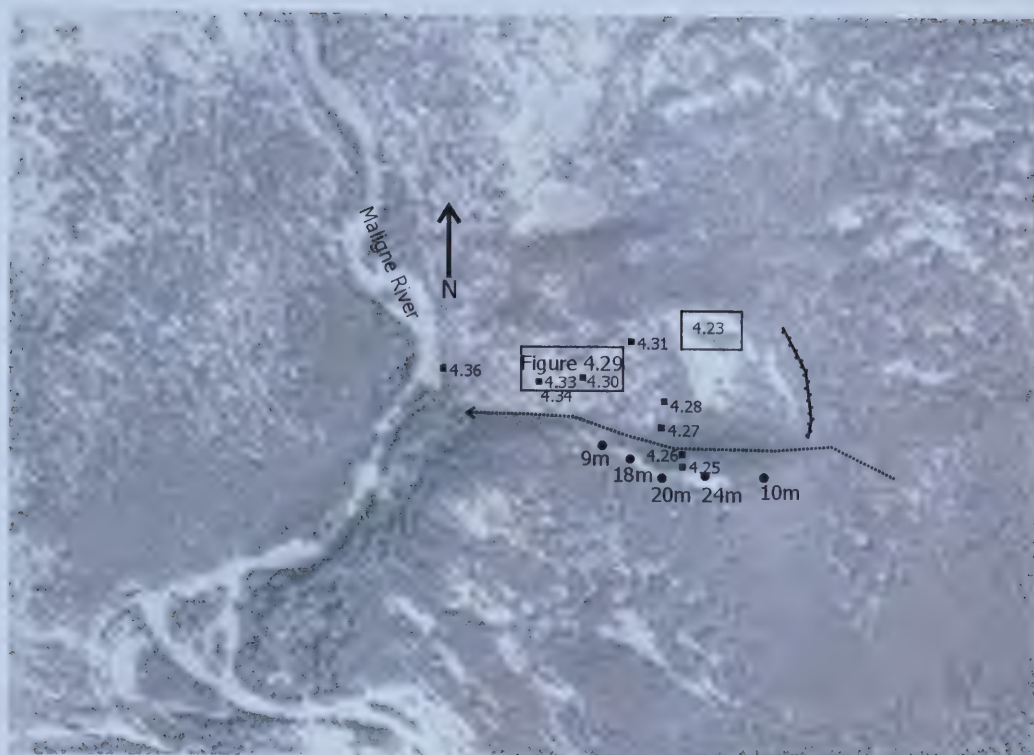
Figure 4.24 – Area from Figure 4.1 enlarged to show the location of figures, the location of a depression through the scarp area, and heights of the south scarp of the Rock Gardens.

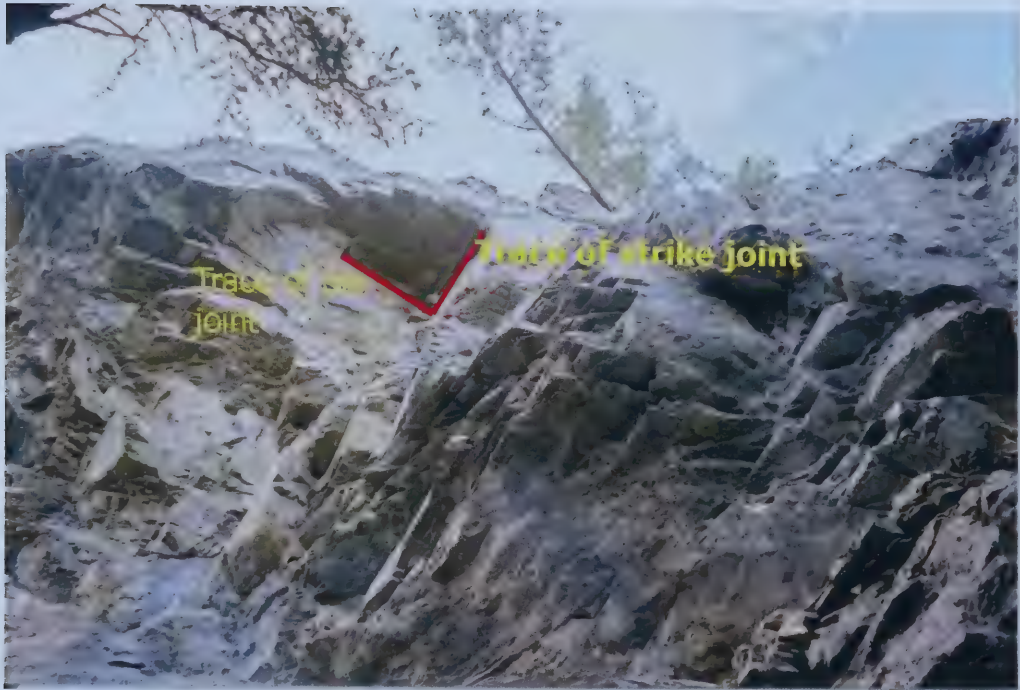
Figure 4.25 – Joint control of the south scarp in the Rock Gardens area. Where the dip joint controls the slope, the slope is an orthoclinal slope, and where the strike joints control the slope, the slope is an anacinal slope.

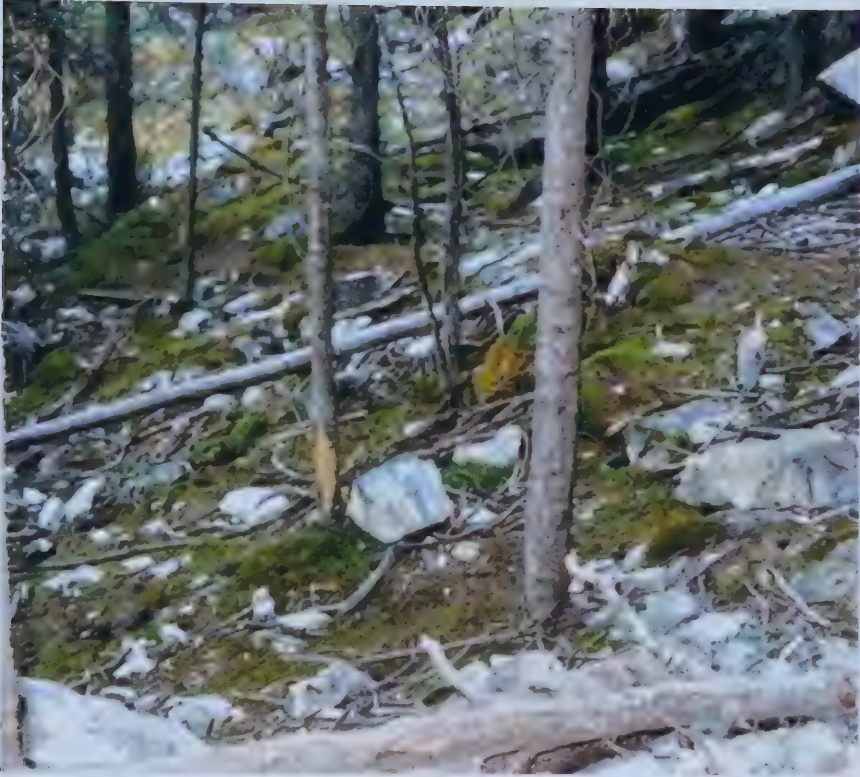
Figure 4.26 – Tree damage and rock fall debris at the base of the south scarp. The damaged tree has a diameter of 10cm.

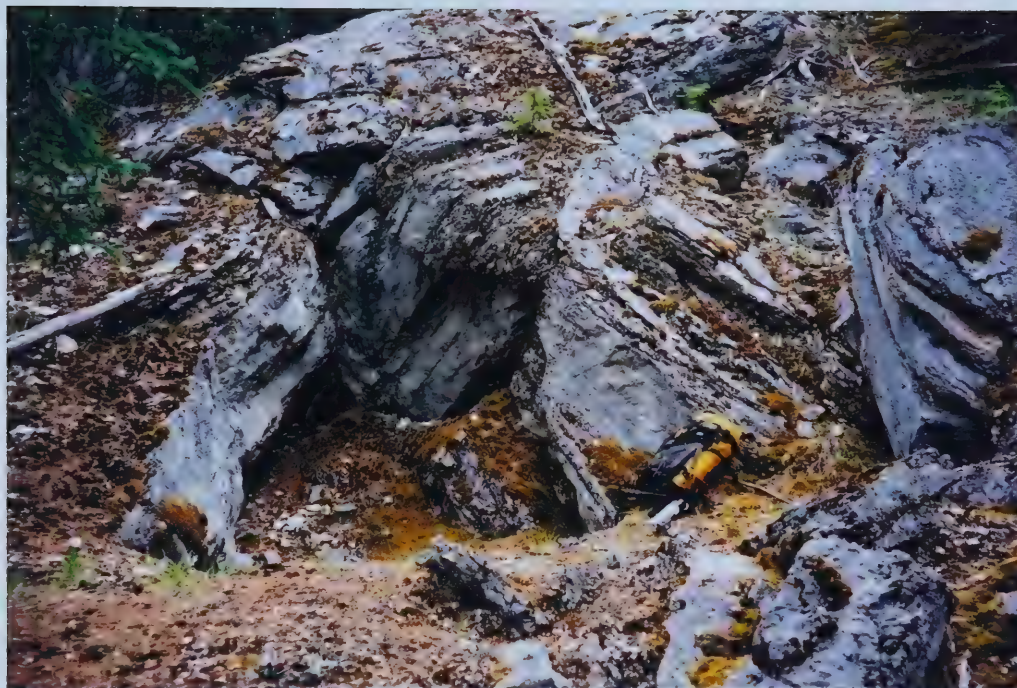
Figure 4.28 – Large, randomly oriented blocks within the transitional area between the scarp and the labyrinth. Backpack is included for scale.

The boundary between the labyrinth and the scarp is not distinct. Vegetative cover on the ground obscures the boundary between the randomly oriented boulders that infill the scarp area (Figure 4.28) and the oriented and regularly spaced boulders of the labyrinth (Figure 4.29). The labyrinth is differentiated from the other areas by the regular orientation of individual blocks, separated from one another along gaping joint planes. The labyrinth is a popular rock climbing area known as the Boulder Gardens (Robinson, 1999), from the regular spacing of blocks in the area.

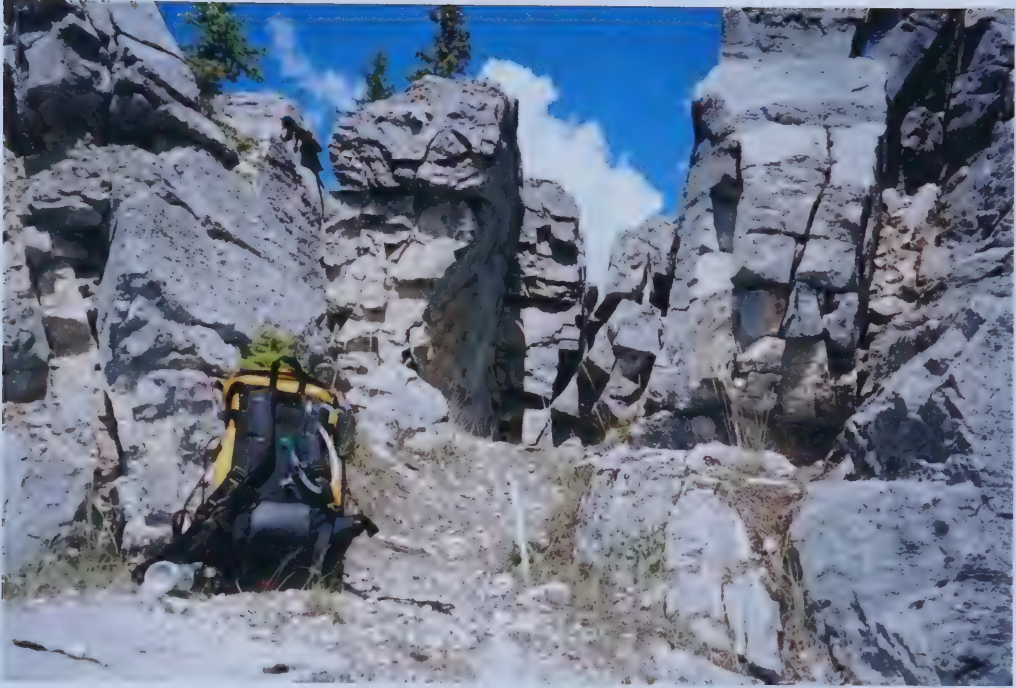
Figure 4.30 – A street within the labyrinth proper. The street narrows to the south, the direction of view of the photograph.

The blocks are separated from one another along joints (Figure 4.29). The separation of joints ranges up to 9.0m with the common spacing between 1 and 2 metres (Figure 4.30). Where joint surfaces separate blocks, pine needles, rock and boulder debris, fallen trees, moss and other vegetation fill in the gaps (Figure 4.31).

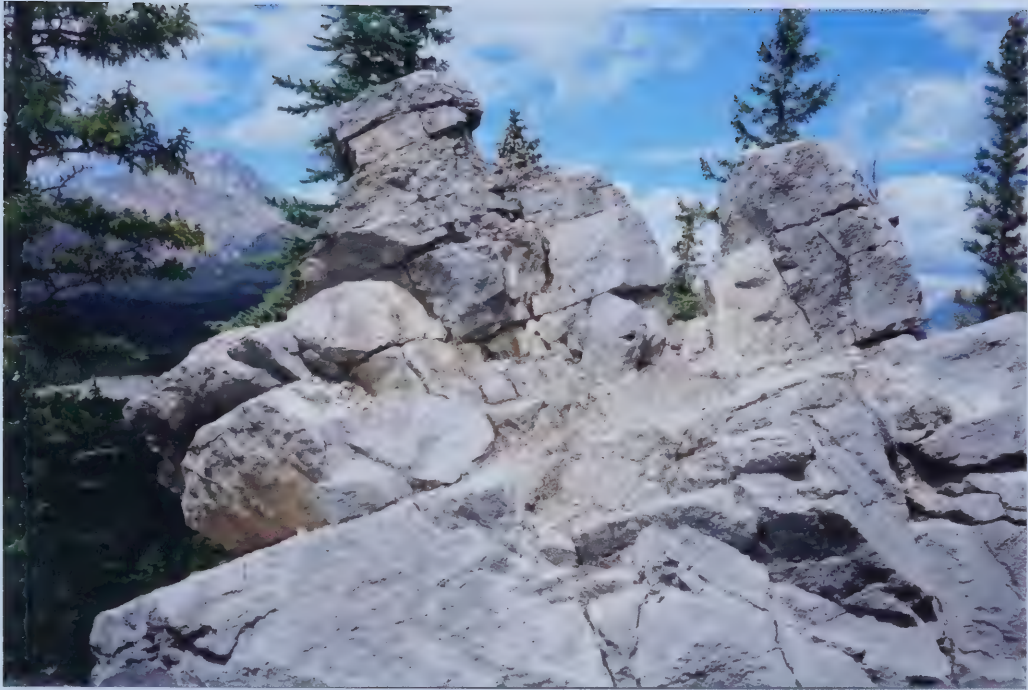
Figure 4.32 – Boulders dipping at  $26^\circ$  resting on top of a rock blocks, indicating that the friction angle of this material is greater than  $26^\circ$ .
